PLUTONIUM RELEASE INCIDENT

OF NOVEMBER 20, 1959

L. J. King
W. T. McCarley

A nonnuclear explosion involving an evaporator occurred in a shielded cell in the Radiochemical Processing Pilot Plant at Oak Ridge National Laboratory on Nov. 20, 1959. Plutonium was released from the processing cell, probably as an aerosol of fine particles of plutonium oxide, via three principal routes:

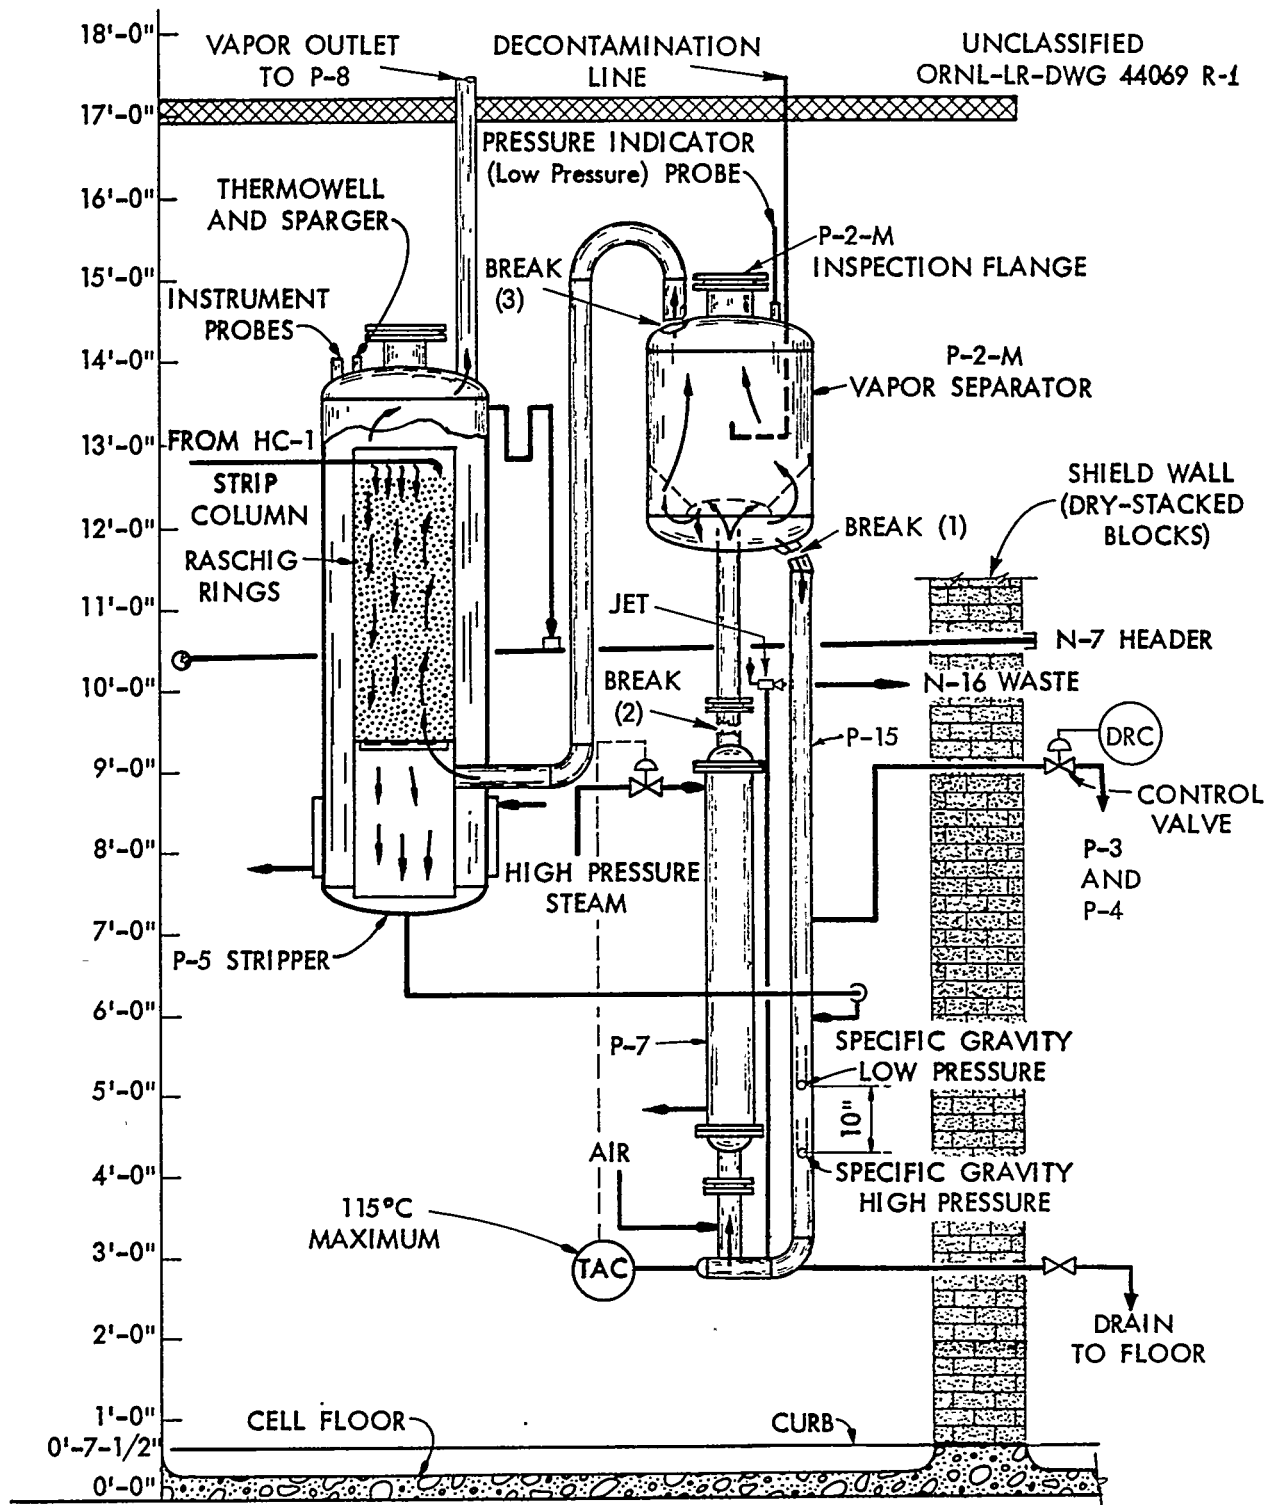
Fig. 3.5. Intercycle evaporator.

The evaporator that exploded was one of two intercycle evaporators used to concentrate aqueous uranium-plutonium strip column product. This evaporator (Fig. 3.5) was not a single piece of equipment but consisted of a steam stripper (P-5), a vapor separator (P-2), a 25-sq ft heat exchanger (P-7), and connecting piping. Overhead vapor was condensed in a 35-sq ft heat exchanger (P-8) and was collected in a condensate catch tank (P-6)

Figure 4.1 is a photograph of a piece of a flared pipe which connected the convection loop heat exchanger to the long nozzle that was welded to the bottom of vapor separator P-2. In Fig. 3.5 the piece is shown between "Break (2)" and the flanged connection just above "Break (2)." It can also be seen protruding from the flange that is near the bottom in the center of Fig. 3.10. (See also Fig. 3.9).

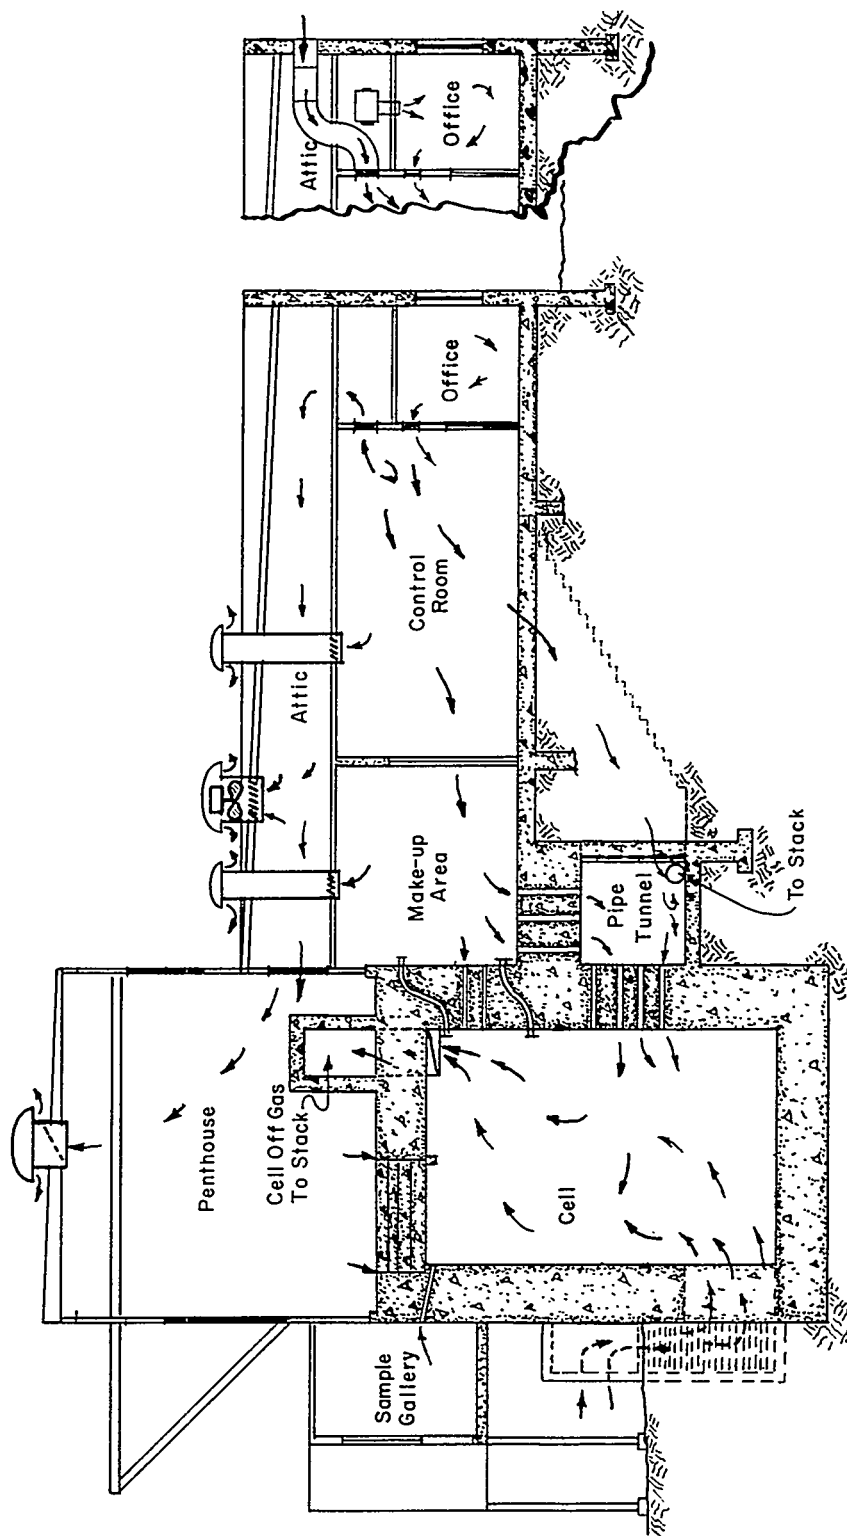
Fig. 7.1. Radiochemical Processing Pilot Plant air flow prior to the evaporator explosion.

vent recurrence. As plants became larger or more complicated and as radioactivity levels increased, the off-gas system was modified, but the use of controlled air flow for air-borne activity control was retained. Figure 7.1 shows the general air flow pattern as it existed just prior to the explosion.

Three major additions have been proposed for the Bldg. 3019 off-gas systems. These include (1) installation of a bank of filters and associated fans and ducting for filtering the hot analytical facility cell off-gas

prior to discharge to the 3020 stack; (2) installation of a caustic scrubber and filters for the dissolver and vessel off-gas prior to its release to the 10-in. stainless steel line to the 3039 stack; and (3) installation of a potassium hydroxide scrubber for the Volatility Pilot Plant off-gas from cells 1 and 2.
